## CENTRAL INTELLIGENCE AGENCY

SUBJECT Rechlin Landing Field

**SECRET****SECRET**EAST GERMANYAIR/MILITARYRECHLIN L/G. 53°20'50"N 12°44'30"E

Cable Supply as at Oct 55

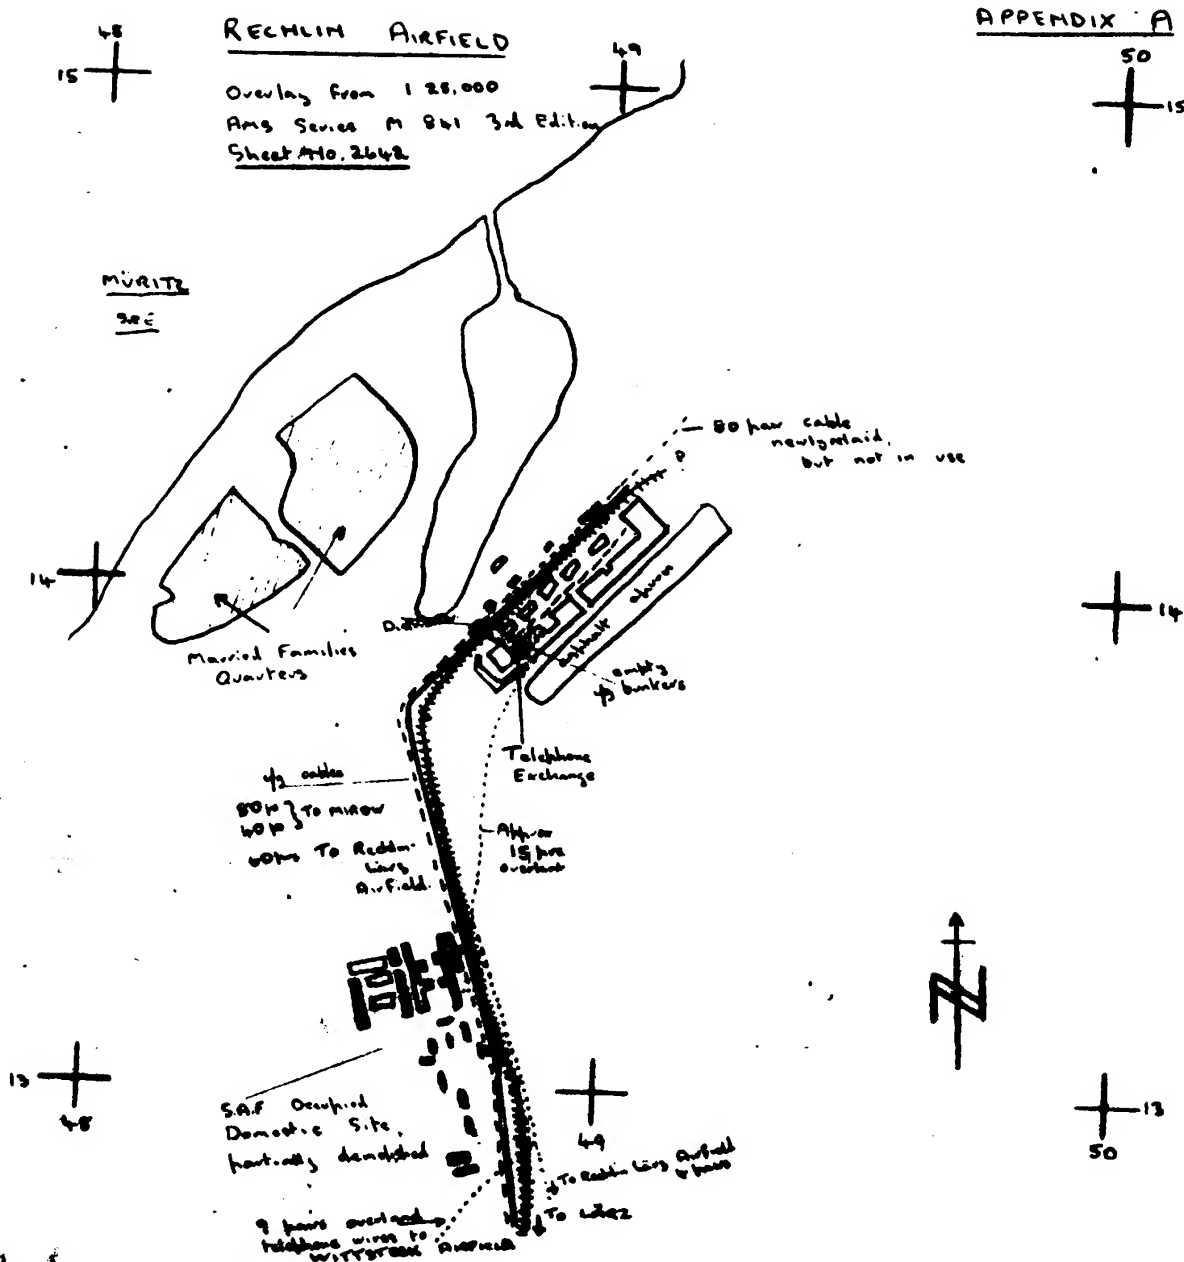
Attached at Appendix "A" is an overlay taken from local 1:25000 (double scale), showing features of the NORTHWEST corner of RECHLIN Airfield.

There are 3 permanent recently re-conditioned underground telephone cables feeding into RECHLIN Airfield, and terminating in the telephone exchange located at MR 4885 1385.

The 3 cables pass through ELLERHOLZ, and the underground bed follows the side of the road along the WESTERN perimeter of the airfield, extending as far as a distributor point located at MR 4875 1390. At this point, the 60 pair cable and the 40 pair cable proceed directly into the telephone exchange located in the ground-floor of a building at MR 4885 1385. The 80 pair cable is broken at the distributor point, and the original cable proceeds NORTHwards along the airfield perimeter, its terminal being unknown. This portion of cable has been renewed for a distance of approx. 600 metres beyond the distributor point, but the lines were not in current use at that time.

At MR 490 140, there is a cluster of reconditioned (and in parts completely rebuilt) buildings which are reported to be used as an SAF H.Q. (for location, see sketch at Appendix "A").
